**Corrosion Control International**

LOCATION: LOMOND – CATS PLATFORM, NORTH SEA

PRODUCT: RETROWRAP HD (6.25mm)

OPERATION: RECLADDING RISERS FROM DEAD WEIGHT SUPPORT  
FLANGE UPWARDS TO RISER CLAMP APPROXIMATELY 6m EACH RISER

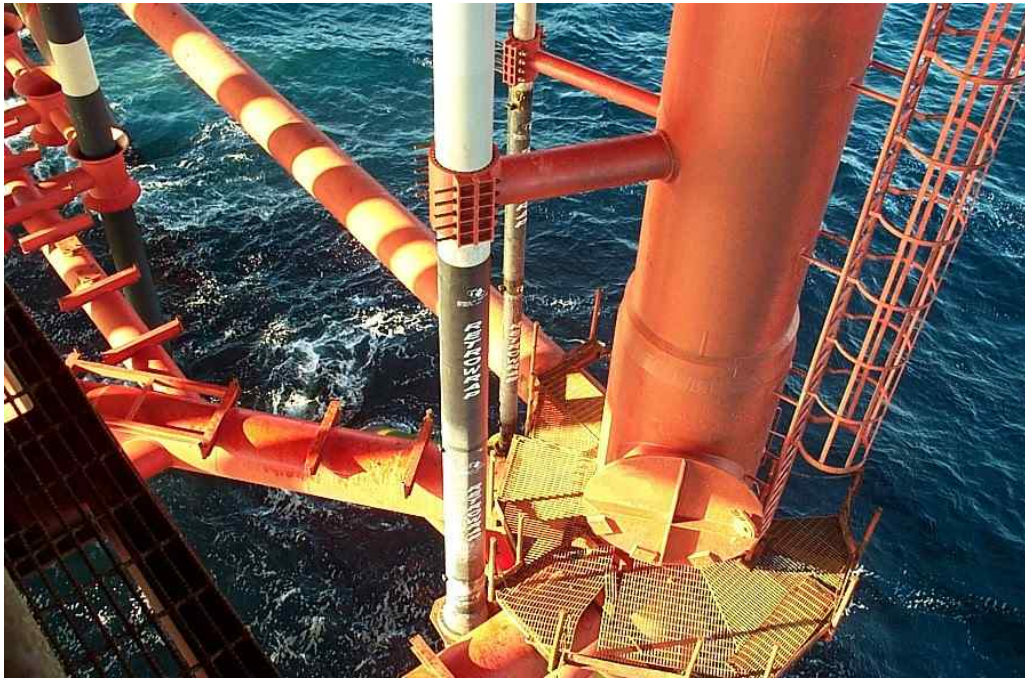
(1)

The extent of coating repair both risers from dead weight support flange bottom center and center to underside of riser clamps top center 20" high temperature gas riser in foreground. Note: Fabric lifting lugs for slinging units into position clearly visible.

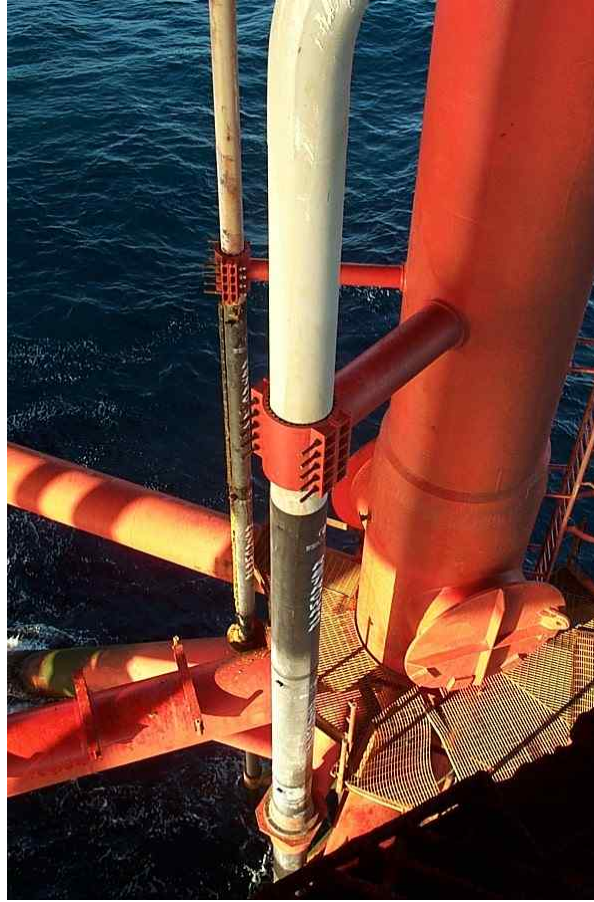
(3)

Full-length closure flanges and overlap interconnecting joints clearly visible together with SS 316 bolting system.

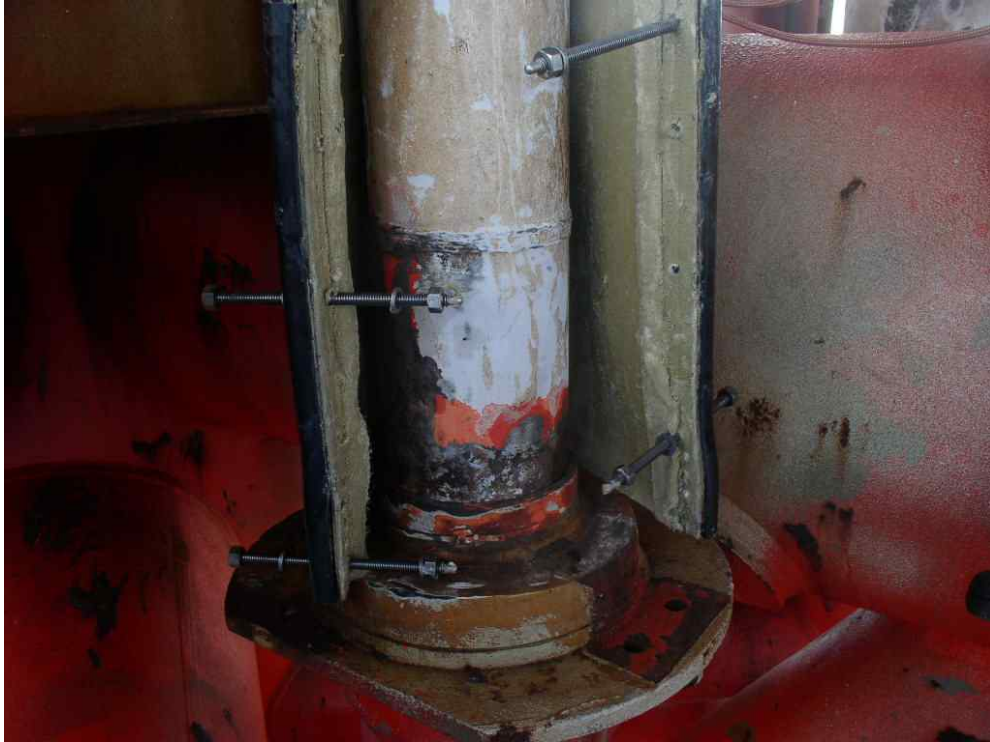
(5)

Dual diameter 244/219 transition unit has been lowered onto dead weight support flange. Note: Draw bolts pre fitted into closure flange.

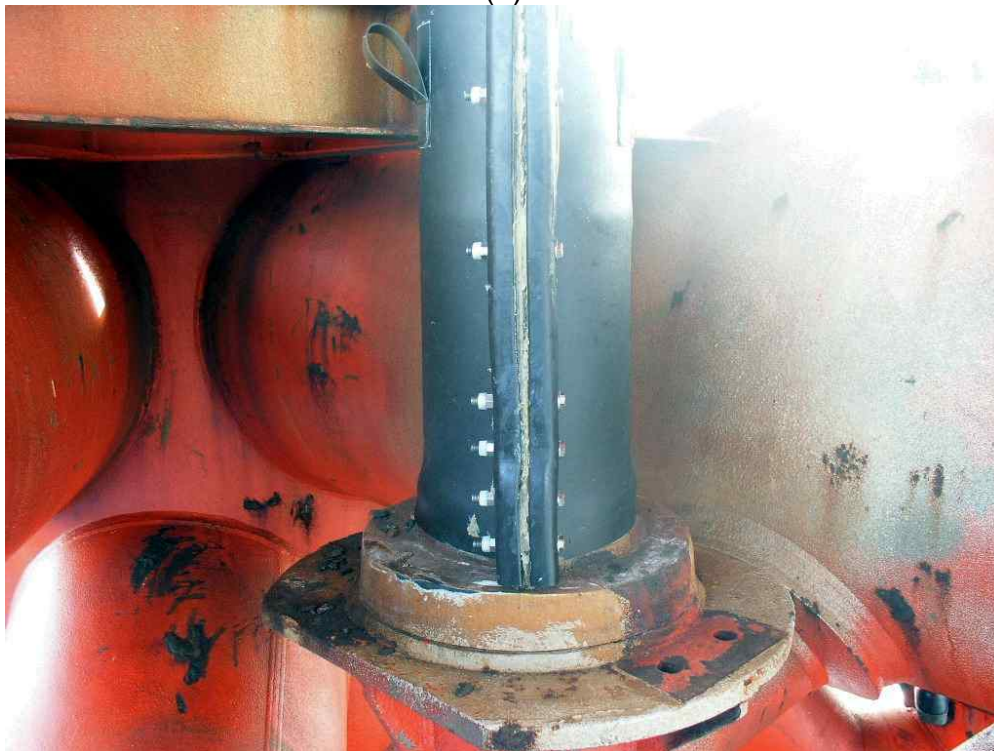
(6)

Dual diameter transition unit fully installed. Factory thermal formed flanges visible at neoprene steel interface. Multi bolts at high stress area.

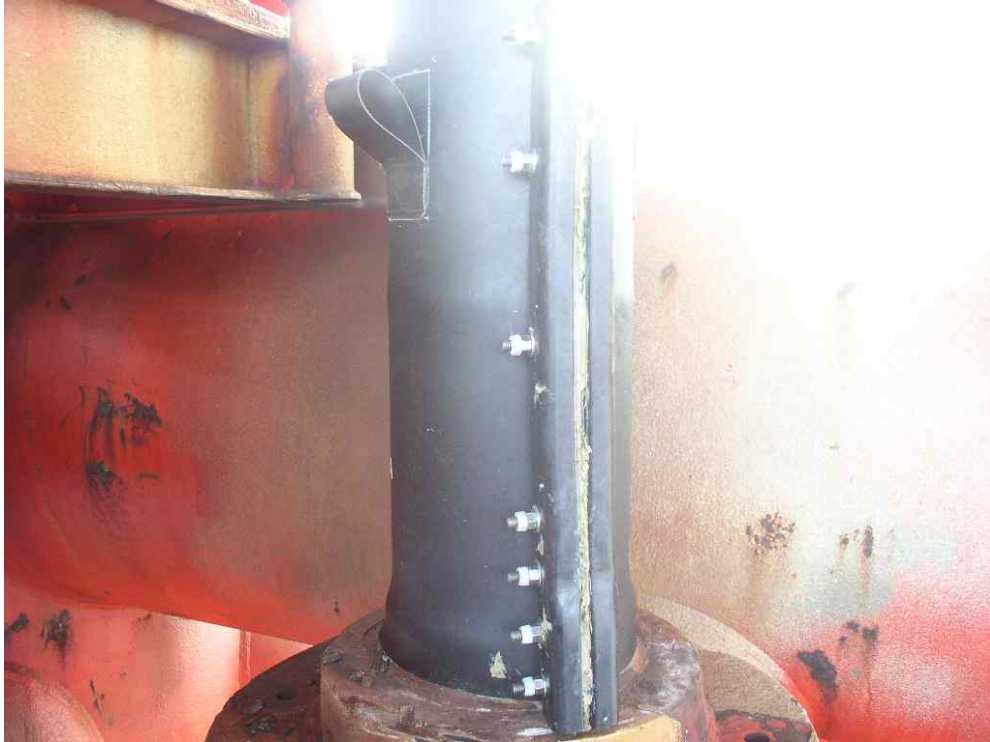
(7)

Lifting lugs clearly visible on 244/219 diameter transition unit.

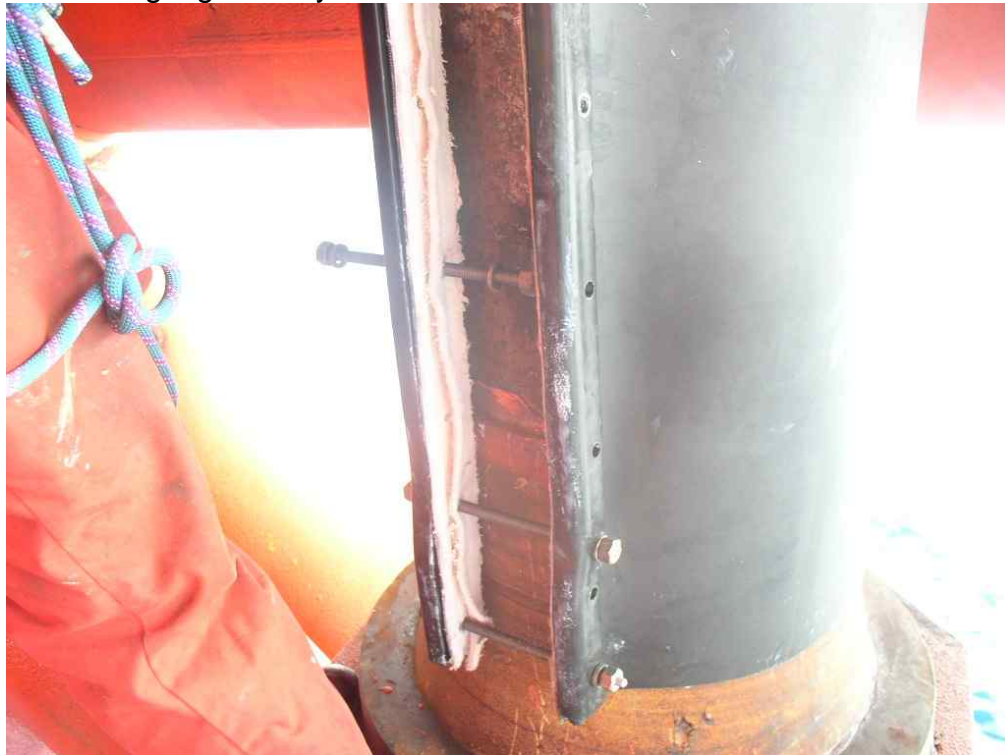
(8)

533/508mm transition unit pre fitted onto existing cutback neoprene riser cladding. Draw bolts in position awaiting tensioning. Note: Inner vertical seal clearly visible together with white high temperature (120° corrosion inhibiting gel).

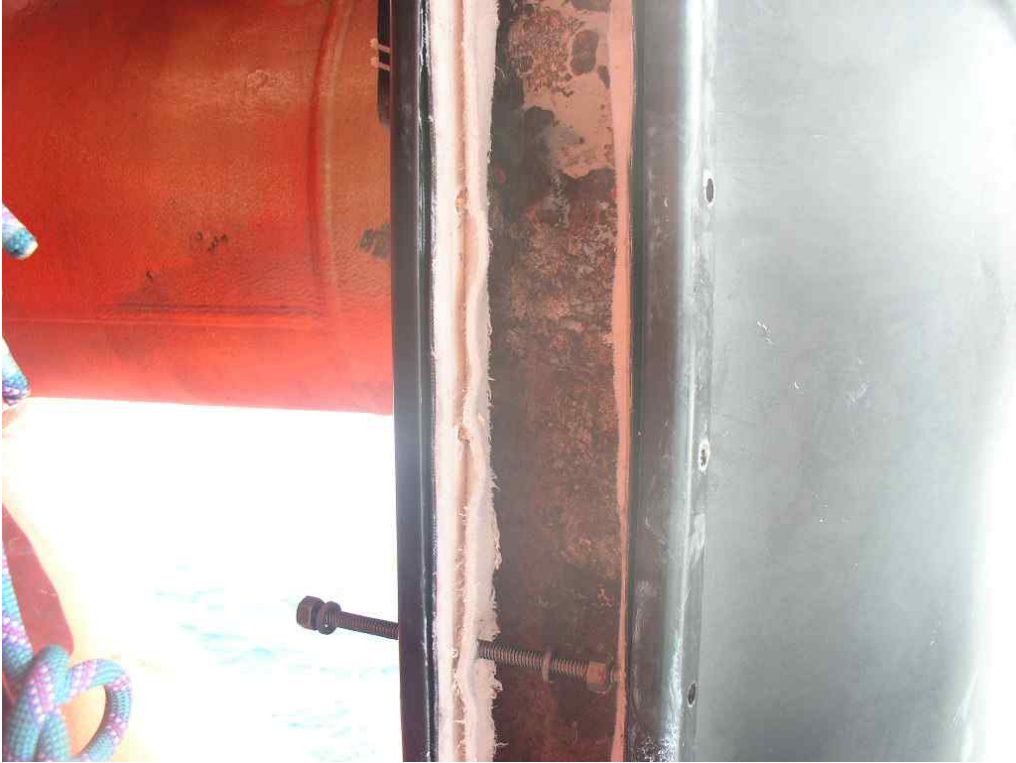
(9)

Close up showing condition of substrate and the fact that minimum substrate preparation is required prior to installation of Retrowrap units.

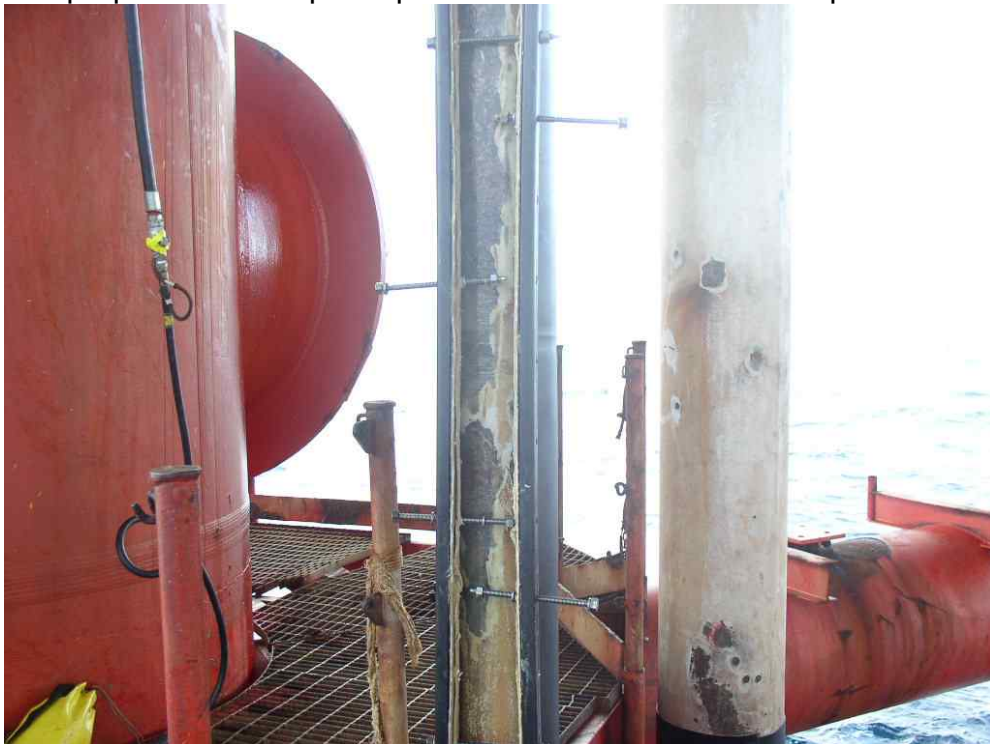
(10)

Both risers. Full-length 2794mm partially pre fitted over 219 condensate riser. Lower four draw bolts to be fitted. Note: Coating damage on 20" high temperature riser.

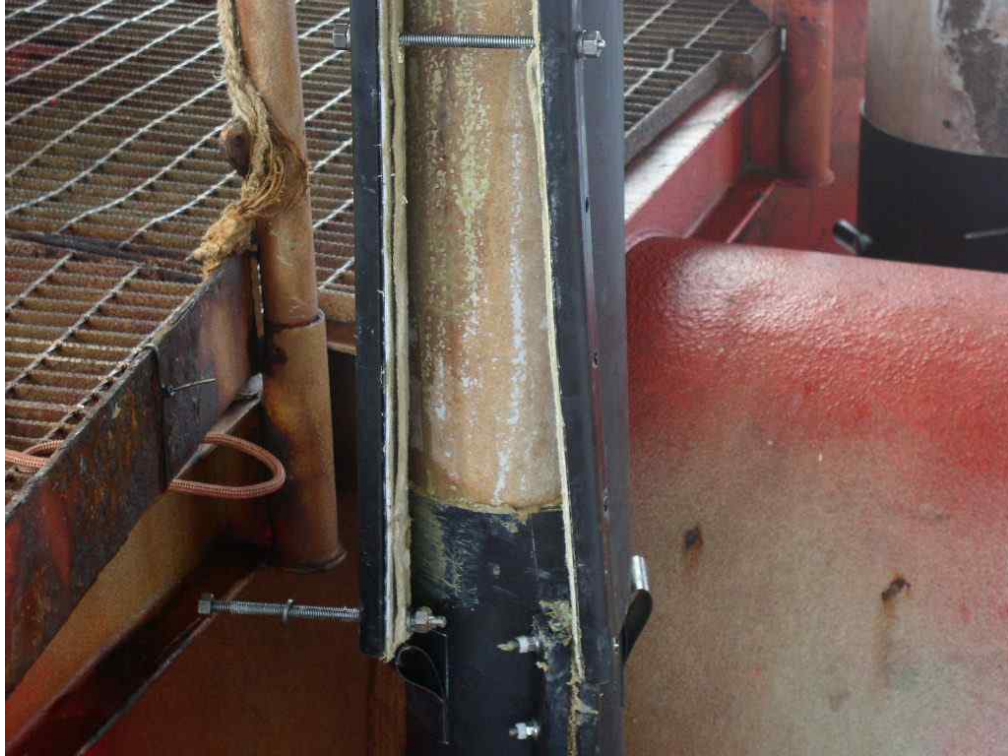
(11)

Full-length 2794mm unit in pre position over sealing skirt of lower unit. Upper end of lower closure flange and lifting lugs visible bottom center.

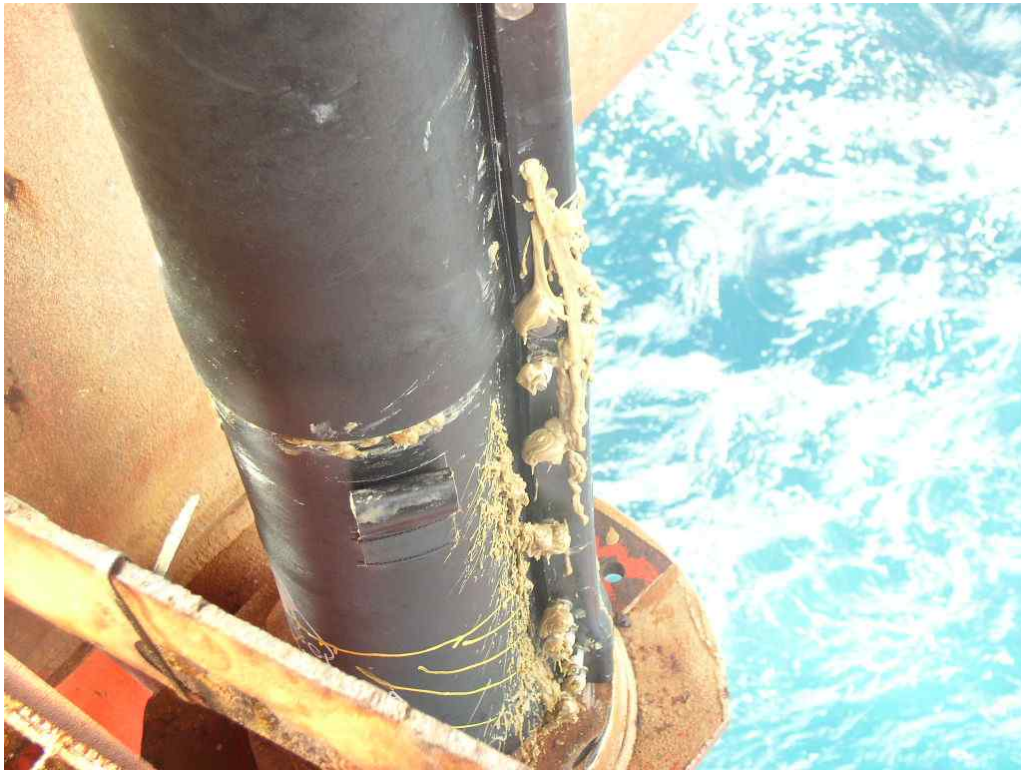
(12)

Completed interconnecting joint showing thixotropic corrosion inhibiting gel exuding from flange and circumferential joint during final tensioning.

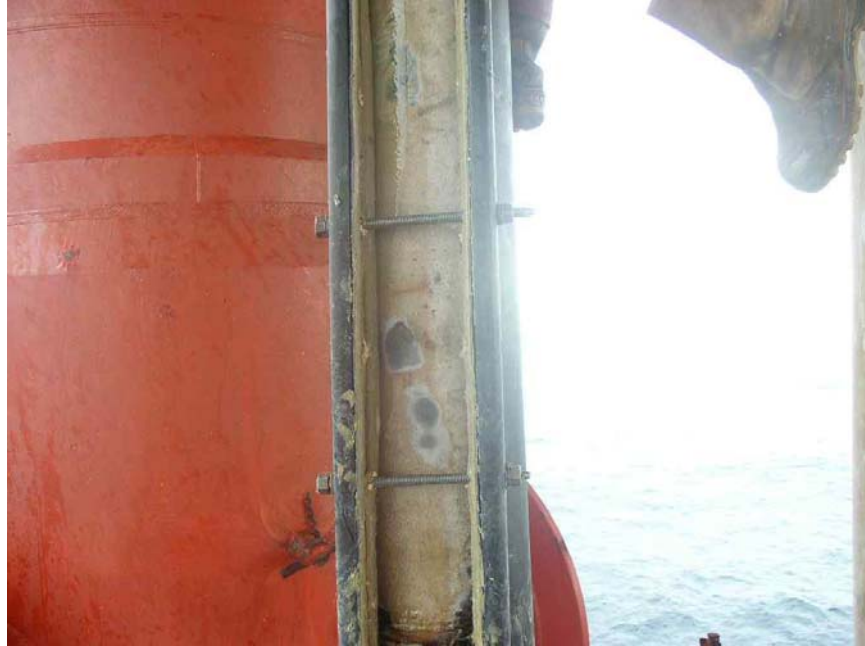
(13)

Pre installed wrap with draw bolts in position awaiting closure by air operated impact wrench. Note: Boots of rope access abseiler.
