MARAVEN 2" AND 6" RISER INSITU RECLADDING TRIALS

LAKE MARACAIBO VENEZUELA OCT 96 - DEC 97

TECHNICAL REPORT

RETROWRAP (STD) WRAPAROUND RISER

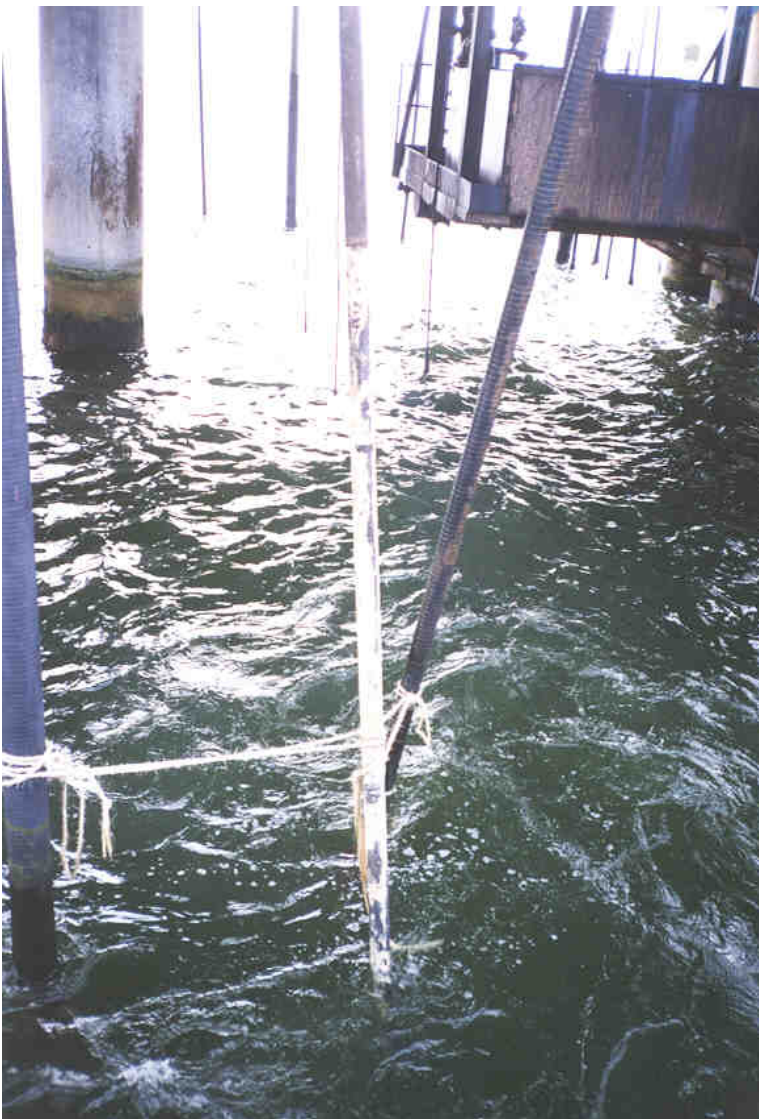
Fig 1

Upon arrival at the first location we found that the 2" wraps had already been removed from the riser; close inspection of which indicated that no corrosion had occurred during the 13 months that the units had been in service (see figure 1 below).

2" riser after rewrap removal. Note the cohesive transfer of gel from the wrap to the riser with zero evidence of corrosion

From the above photograph it can be seen that the thixotropic gel factory impregnated into the wrap in a layer had cohesively whetted out upon the riser surface to provide active primary protection. Examination of the removed wrap (see Figure 2.) confirmed that no corrosion had occurred during the service life and that the wrap had not sustained any exterior damage while in service.

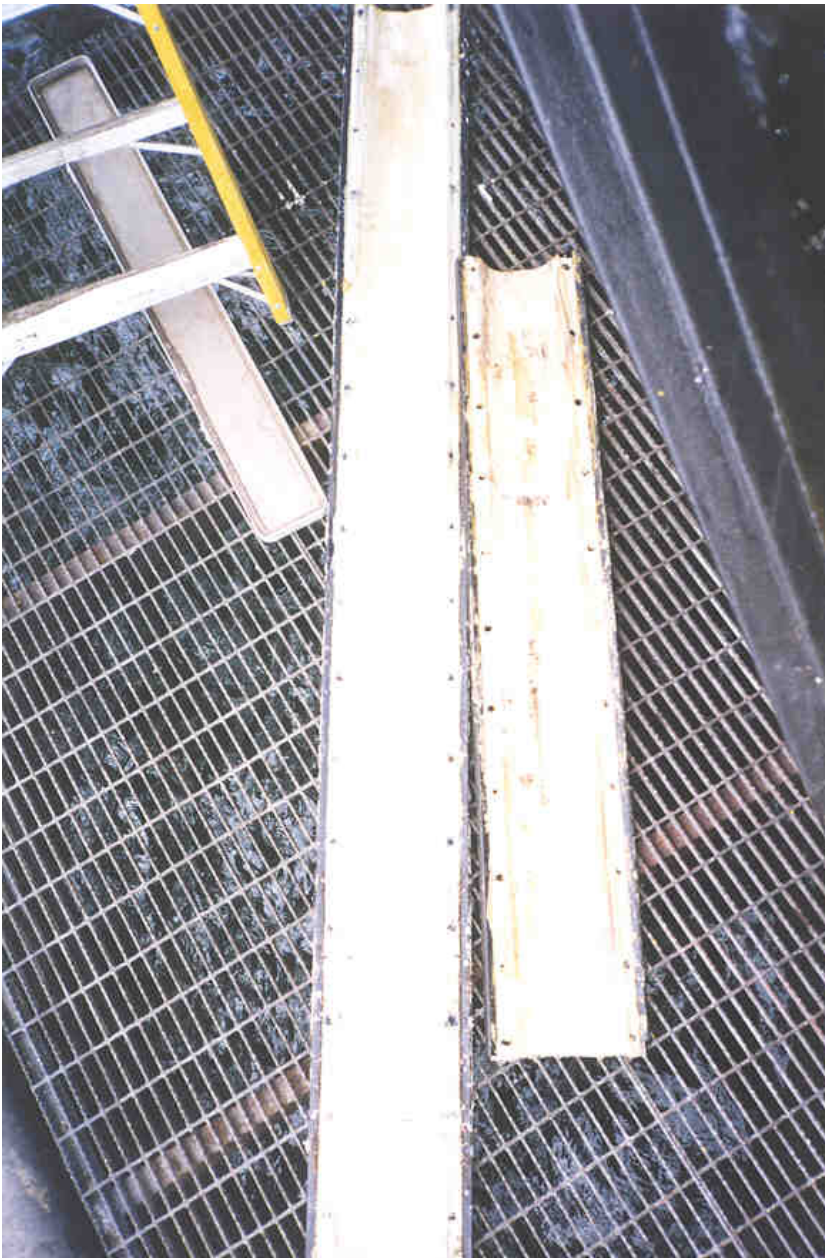
Fig 2

Even distribution of gel within the inner layer. Note the discoloration of the upper (shorter) section due to transfer of original coating debris

It should be noted that the staining that appears on the inner layer of the 2" X 1.5M section (Figure 2.) was from the coal tar epoxy coating, which had probably not been wiped down after marine growth removal and prior to wrap installation.

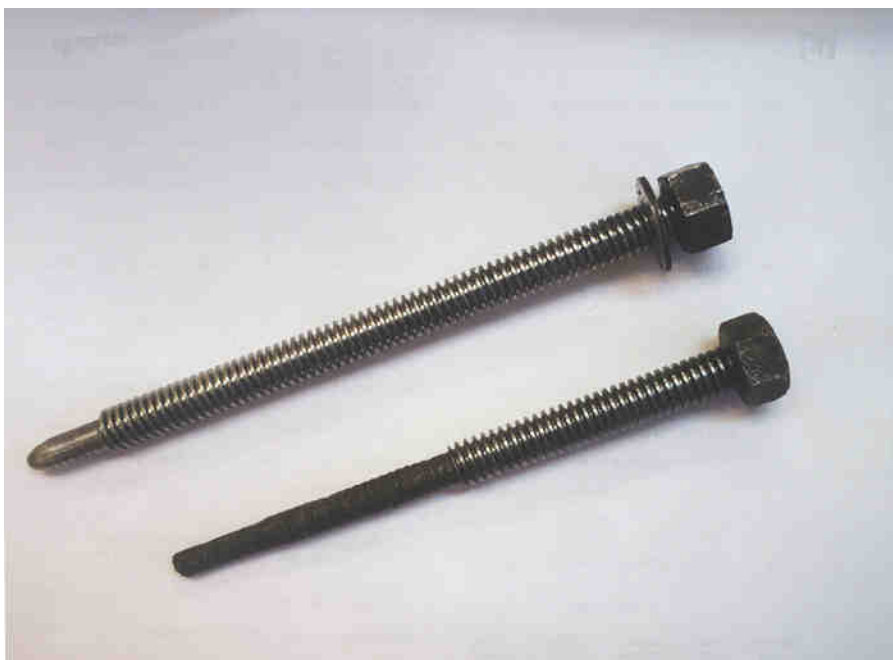
Fig 3

The divers also recovered a 150mm X 12mm diameter carbon steel draw bolt which had inadvertently been left in position by the divers in the sub-sea section during the initial installation (see Figure 3.) which shows that extensive corrosion had occurred to the exposed 85mm section of the draw bolt which had protruded from the closure flanges, while the remaining section (which had been protected by the corrosion inhibited gel contained within the flange assembly) had maintained the draw bolt in perfect condition. A text book demonstration of the corrosion protection performance of the inhibited gel.

A comparison of draw bolts (as supplied) with bolt after 13 months exposure. Note almost 50% metal loss on the exposed section

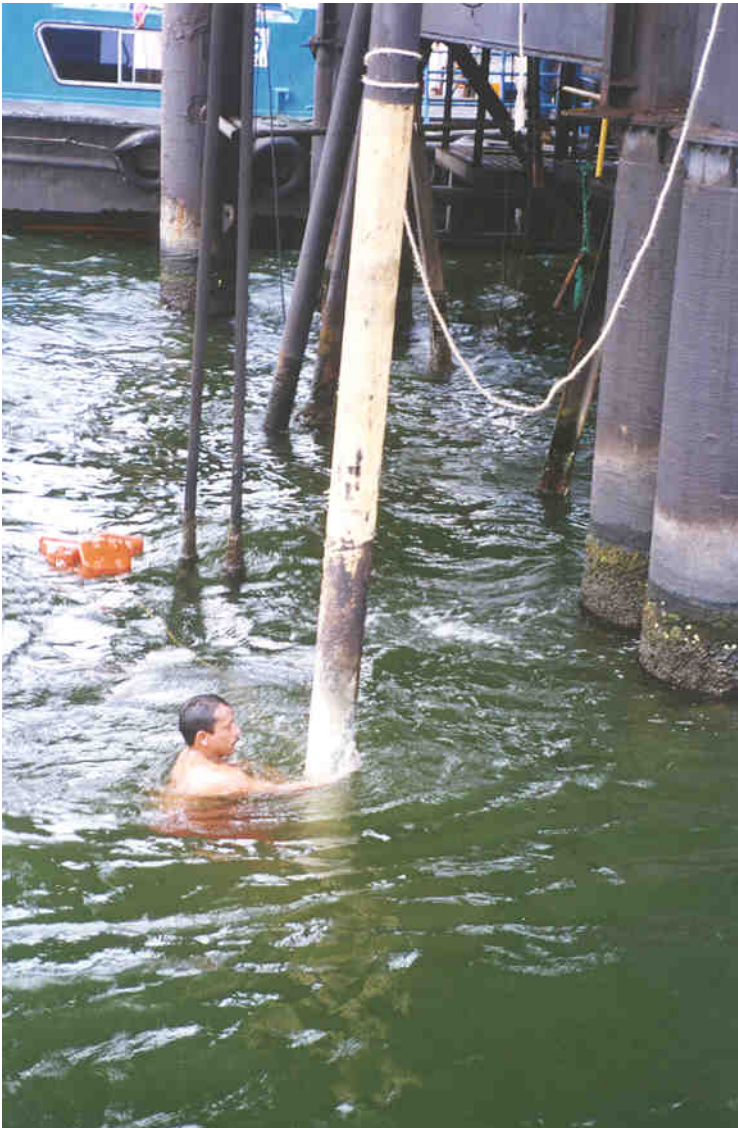
Fig. 4

Following inspection of the 2 inch risers and wraps, we traveled to the next platform where the divers had removed the wraps from the 6 inch risers which had been installed in 3 x 1.5m sections (See Figure 4). Close inspection revealed as with Figure 1 no post wrap installation corrosion of the riser had occurred with cohesive transfer of the gel from the wrap to the riser surface.

The off white color shows the even cohesive transfer of the gel to the riser surface. Note: The darker area is where the gel was removed by diver to observe the substrate.

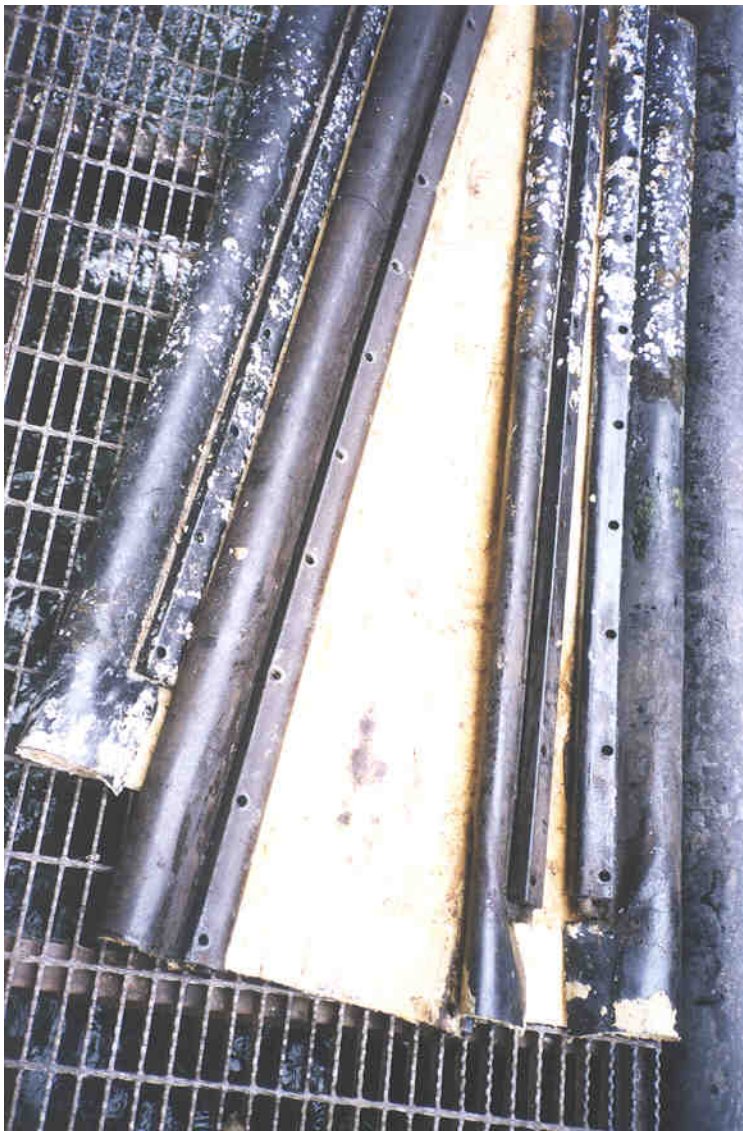
Fig. 5

The divers reported that all the stainless 316L bolts could be removed without difficulty and that the removal of the wraps had been achieved very quickly (see Figure 5) Very light marine growth had occurred on the external wrap surface. Some discoloration of the inner layer had been caused by the debris of the original coating including the inclusion of some barnacle shells following removal of marine growth prior to the original installation of the wrap in 1996. The three number overlap joints proved to be effective with no evidence of water ingress into the joint area.

No external UV degradation of the outer fabric or closure flange. Very light marine growth. Note: Slight localized discoloration caused from debris from original coating after removal of marine growth prior to original installation.

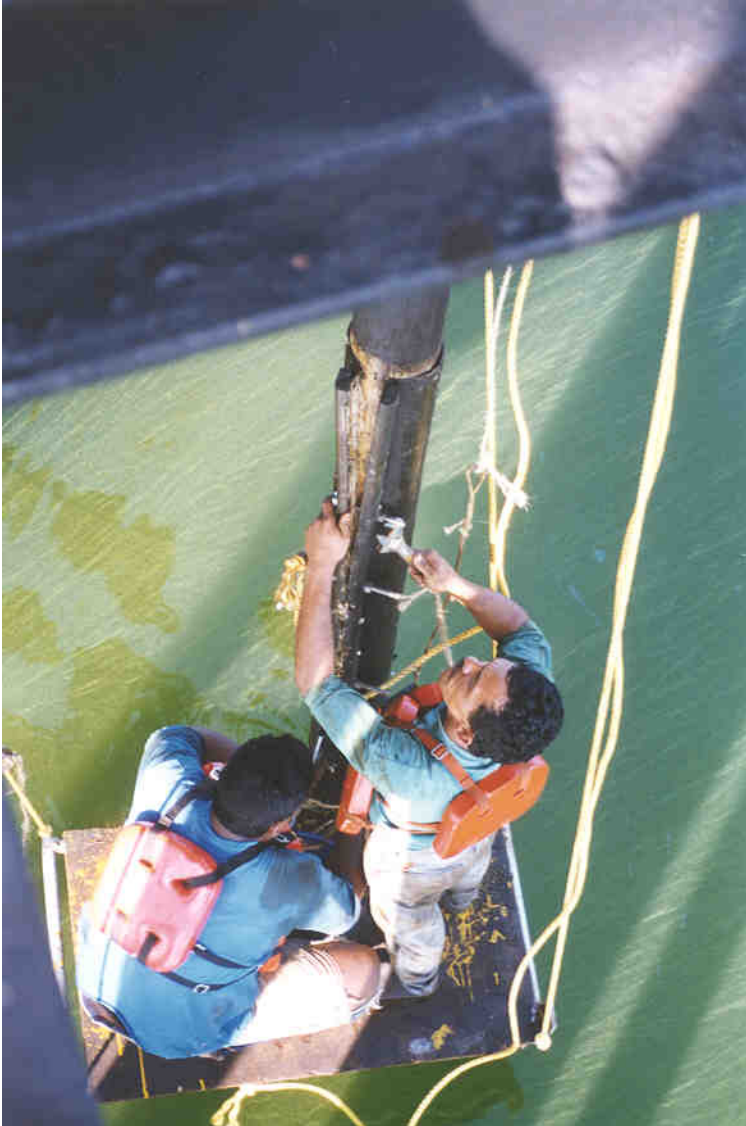
Fig. 6

The upper 1.5m long wrap was installed by riggers using a platform suspended from the upper work deck. Having had the advantage of being able to observe the divers installing the upper section of the second wrap above water, the installation of the third wrap went very easy and the total time of 45 minutes was a credible effort particularly when considering they were using hand tools only (see Figure 6).

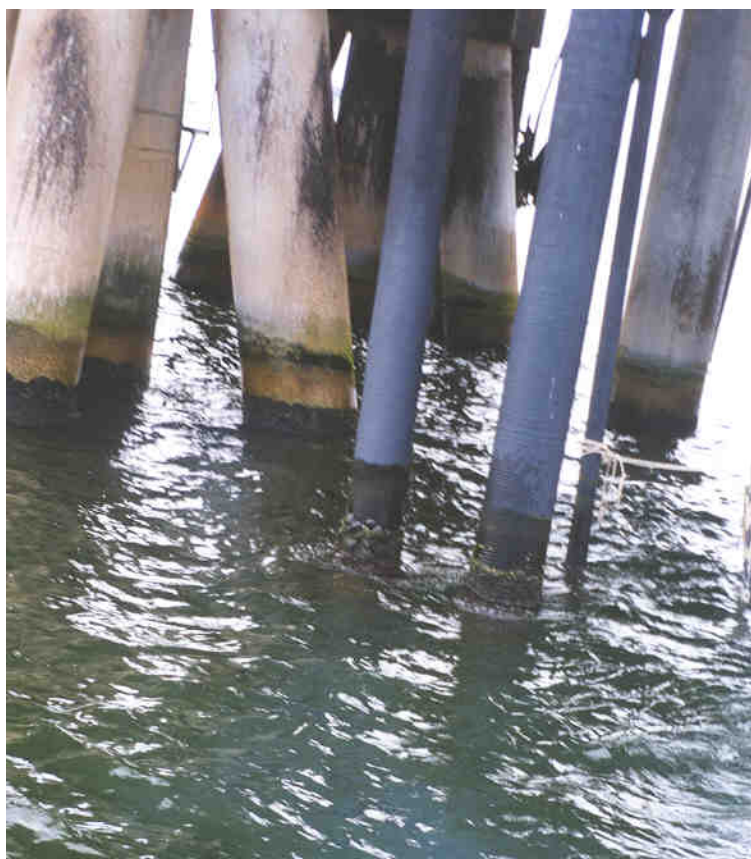
Fig 7

Observe riser next to  
concrete raker pile.  
Note severe disbondment  
of neoprene at water level

While inspecting the 2 inch risers, the writer observed excessive blistering under the neoprene coating on an adjacent 8 inch riser. We would recommend that at the earliest opportunity the neoprene coating be removed and wall thickness measurements be carried out to establish the percentage metal loss followed by application of retowrap which in this instance would overlap the existing neoprene coating by minimum of 150mm (see Figure 7 next page).

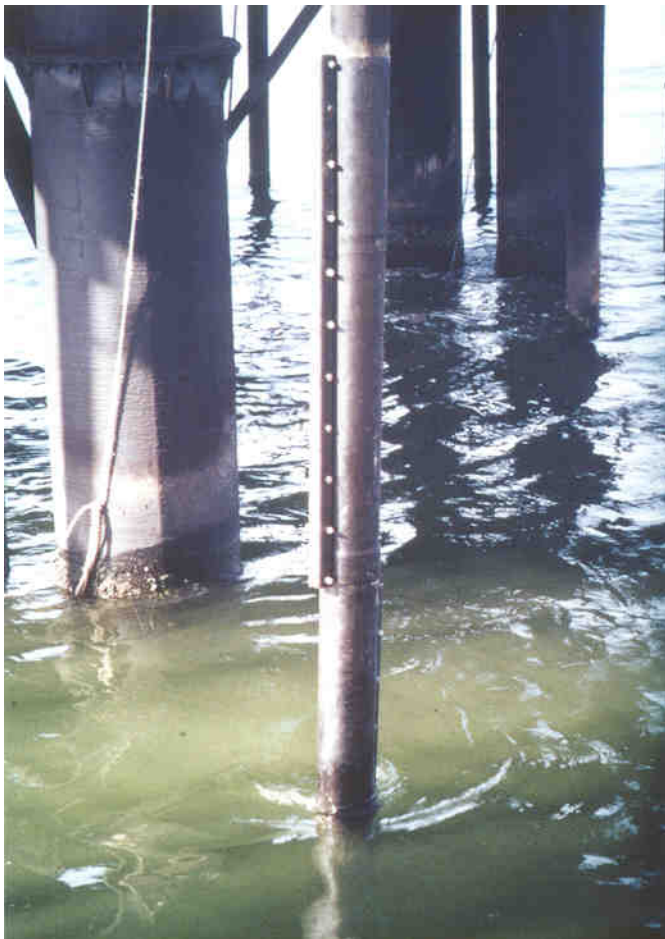
Fig 7A

Completed overlapping & wrap installation on 6" riser.  
Note: Outline of the lower wrap integral seal is clearly visible and position of flanges.  
Also fact that the thixotropic gel has been caused to exude from wrap at the upper wrap riser/interface
