**CALTEX 610 Ø JETTY PILE WRAP TRIAL**

**CALTEX REFINERY SINGAPORE 9TH JUNE 1998**

**TECHNICAL REPORT**

**RETROWRAP (STD) WRAPAROUND PILE**

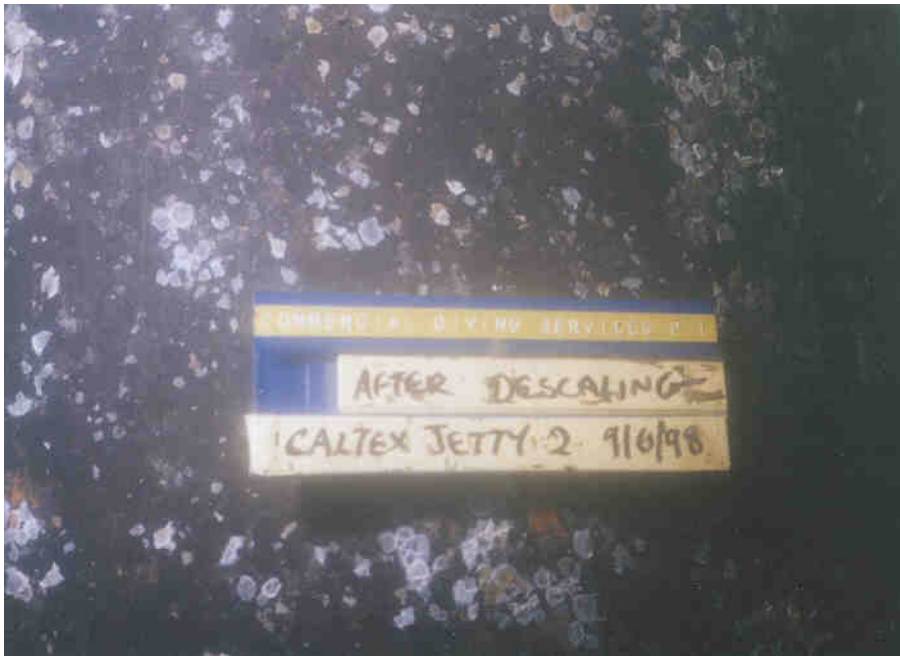
Figure 2

Since Retrowrap provides active corrosion protection by the reaction of corrosion inhibitors contained within the thixotropic gel impregnated into the inner layer of the wrap surface, substrate preparation is reduced to its simplest form. The divers were able to manually prepare the pile by using long handled scrapers in approximately 15 to 20 minutes for the total 4 meter length required to a standard acceptable to CCI. (See Figure 2)

Underwater photograph of substrate preparation after removal of marine growth and delaminated pile coating

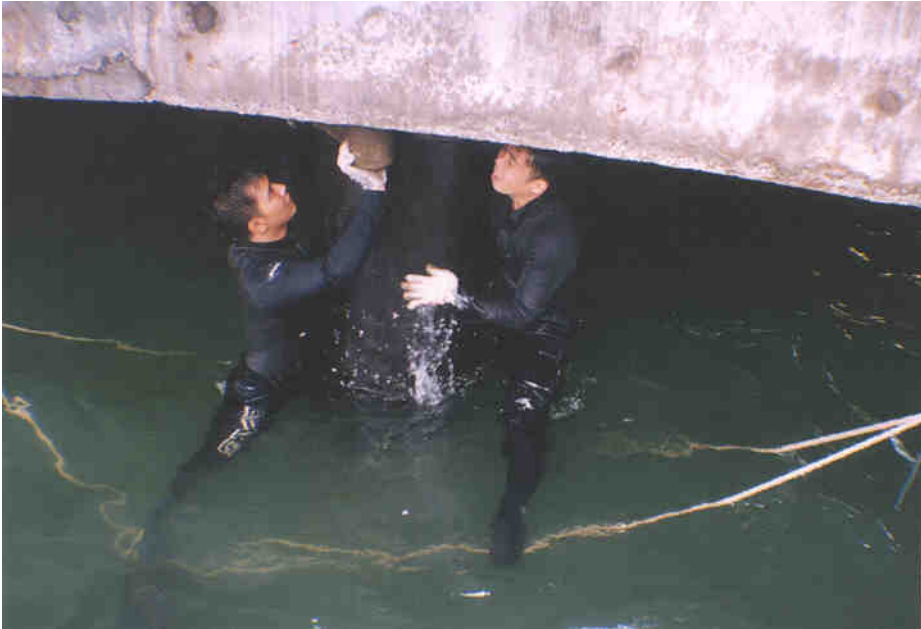
Top seal comprises of a 150mm x 2mm x 10m roll of polyester felt impregnated with the same thixotropic gel as used within the wrap panel. The tape is wrapped around the pile interface such that 100mm overlaps the vertical pile while 50mm is positioned against the pile cap to form a roughly triangular section collar. (See Figure 3 & 4) Note: The top seal also makes allowance for the slight reduction, approximately 1 percent, with the wrap length during tensioning and provides the diver with a 50mm positioning tolerance when lifting the wrap into final position prior to closure.

Divers installing top seal tape while safely standing within cats cradle

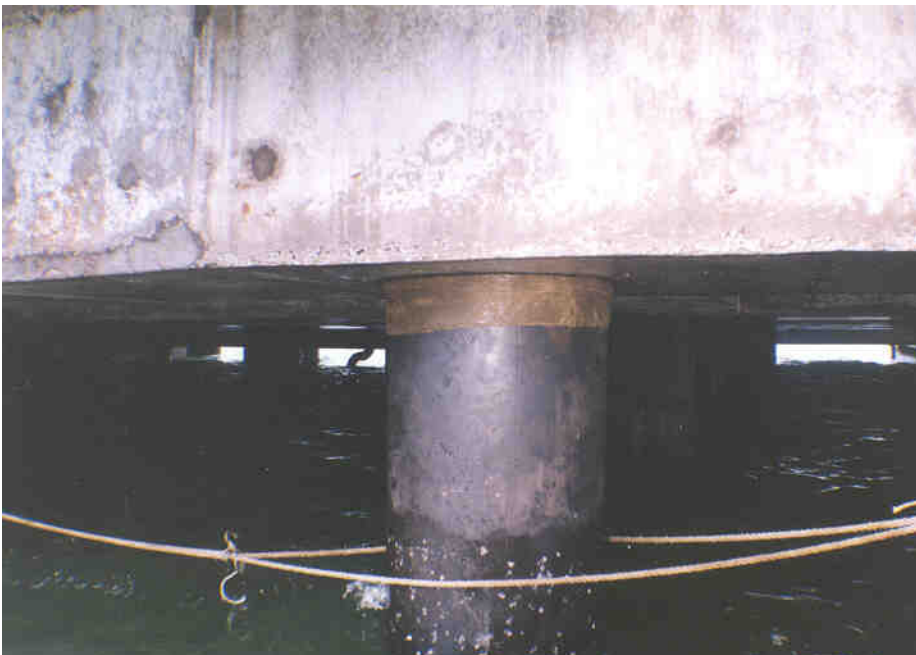
Figure 4

Top seal in position. Note fillet extending over pile cap surface.

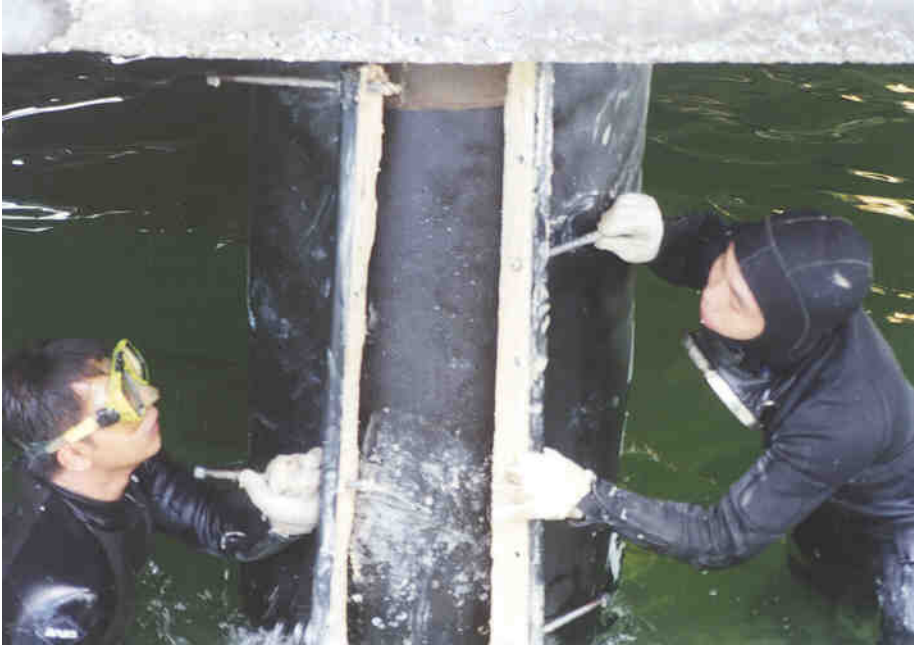
Figure 5

Due to tide levels and lack of small boat access, the upper wrap (see figure 5) was installed by divers standing within cat cradle. The draw bolts shown were preinstalled in both closure flanges in opposing directions to provide the divers with lifting facilities prior to being driven through the adjacent flanges (See figure 6).

Draw bolts extending from flanges to provide lifting facilities

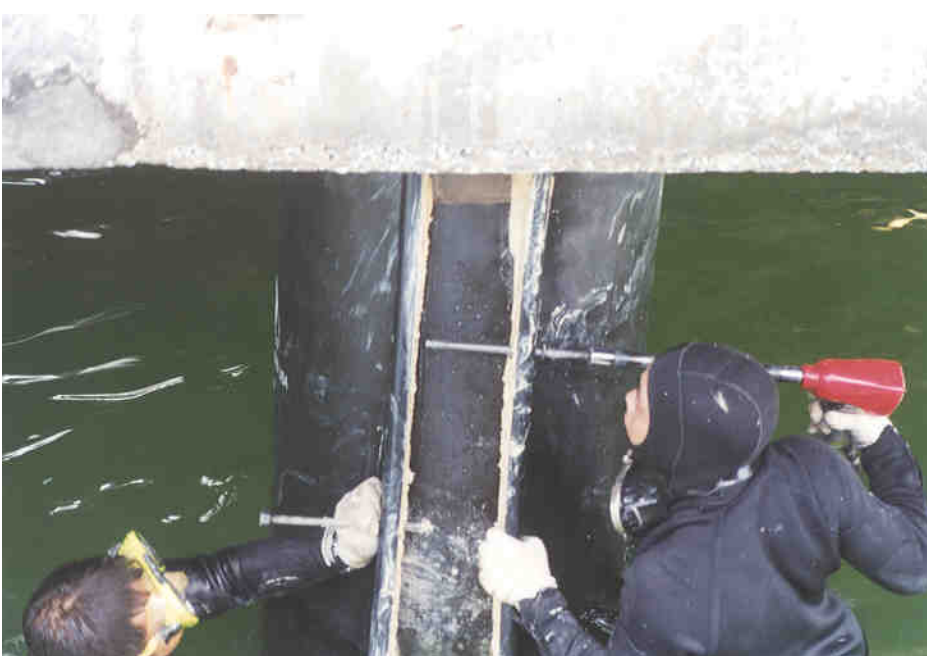
Figure 6

Divers using compressed air impact wrench to tighten flanges.

Installation continued by exerting stainless steel 316L permanent fasteners between each draw bolt and tightening using a 9/16 socket fitted into an air operated impact wrench. At that point, the draw bolts were sequentially removed from the flanges working from the top down since for this application the draw bolts also provided “ladder access” for the divers to the upper section of the wrap. Installation was halted after 1.25m had been completely installed leaving 750mm, the lower section of the upper wrap, open to accept the circumferential sealing flap of the lower wrap.

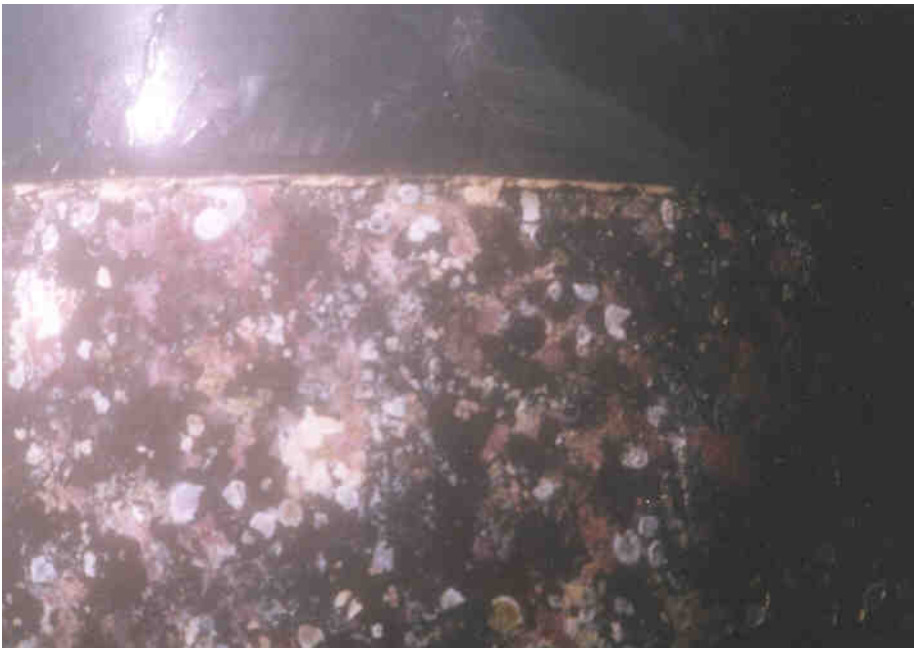
Before tensioning the wrap, the divers were easily able to lift the unit underwater to engage the underlap of the circumferential interlocking joint and repeat all tensioning operations as carried out for the upper wrap. Permanent bolts were fitted as shown in Figure 7 and the gel was observed to have exuded evenly around the lower edge of the wrap insuring a long-term satisfactory seal.

Underwater photograph showing gel exuding from lower edge flange ensuring that all surfaces under the wrap is fully encapsulated with gel.

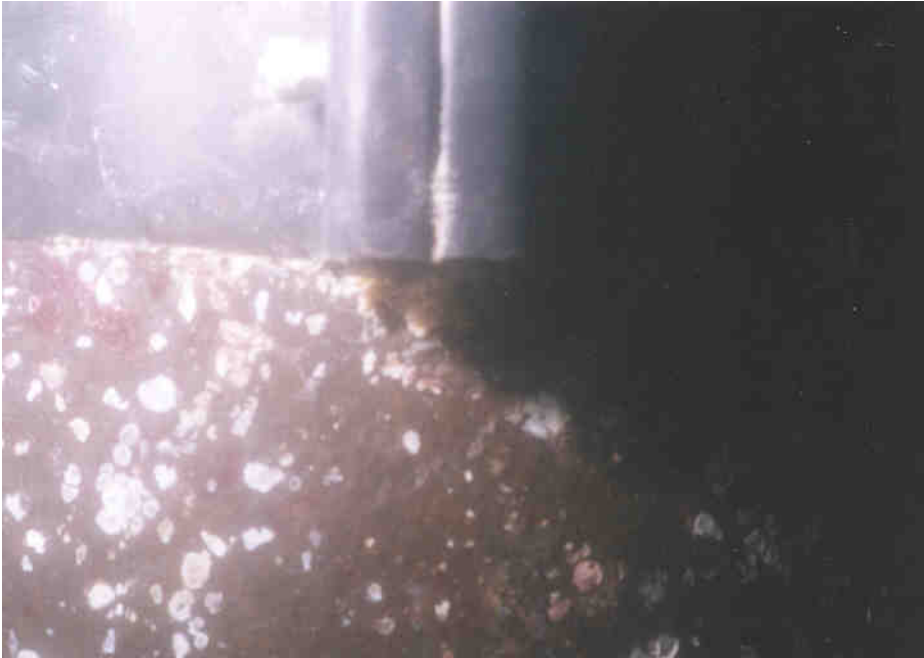
Figure 8

Underwater photograph of gel exuding from Retrowrap flanges permanent fastener & locknut fully tightened.

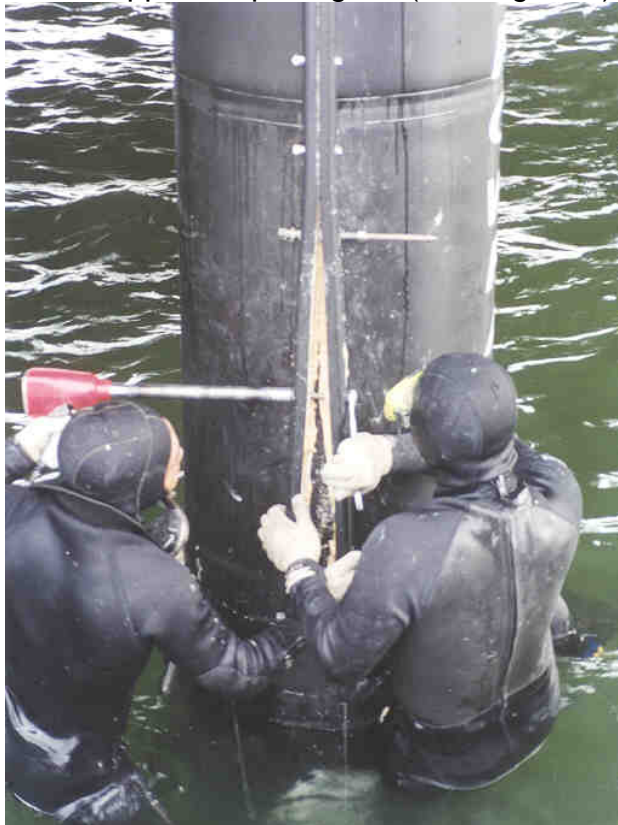
Figure 9

With the arrival of the observers on board the diving vessel, installation of the upper wrap recommenced with the divers inserting draw bolts in the lower section of the upper wrap flanges. (See Figure 9)

Note: Thixotropic gel being exuded from closure as flanges are being tightened.

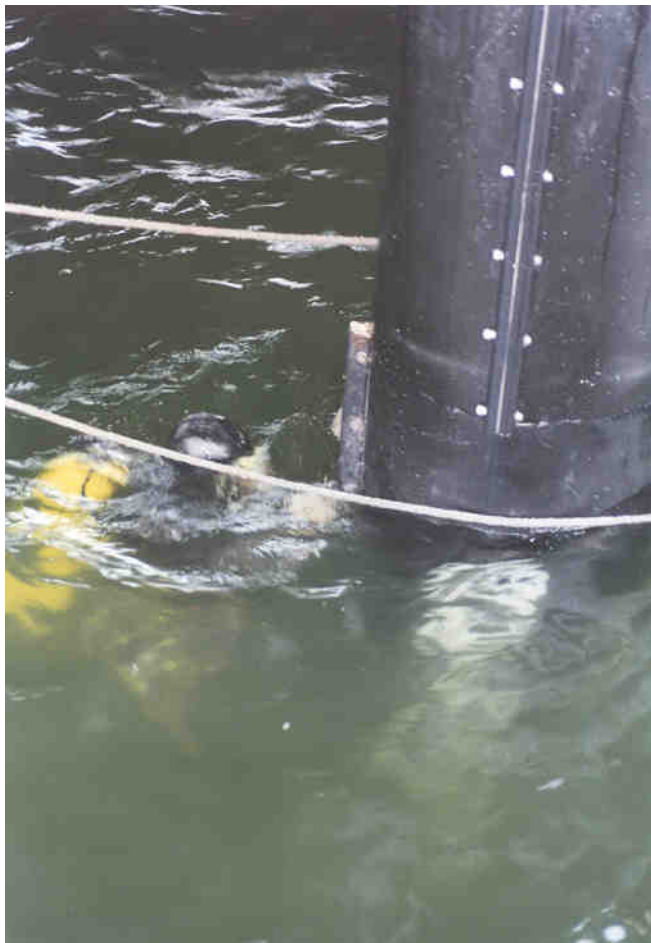
Figure 10

Upon closing the lower section of the flanges, the outline of the underlap seal was clearly visible in the outer skin. Permanent bolts were fitted. The remaining draw bolts were removed after final tensioning and the permanent fasteners fitted in the vacated holes completing the installation. (See Figure 10) Note: For the record, the writer would comment the divers should have been using a self powered industrial compressor in lieu of the small paint spray compressor which had proved totally inadequate to operate the impact wrench on a continuous basis. This resulted in the wrench continuously stalling under load the results being a considerable increase in installation time. See installation operation recommendations.

Note: Overlap 100mm joint section of lower wrap. Flange positioned approximately  $90^{\circ}$  from upper wrap flange.

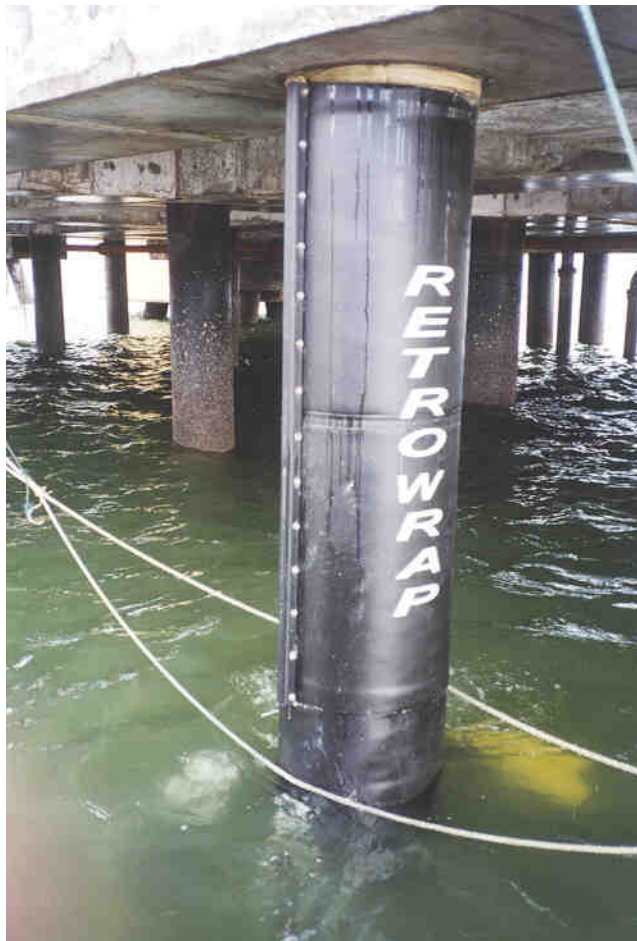
Figure 11

Completed installation of upper wrap. Note top seal forced against pile cap by induced tension within wrap and outline of interlocking seal of lower wrap
