JUPITER, FLORIDA

Corrosion Control International (Division of Slickbar Products Corp)
18 Beach Street, Seymour, CT 06483 U.S.A.
Ph: 203-888-7662 • Fax: 203-888-7720 • info@slickbar.com • www.slickbar.com

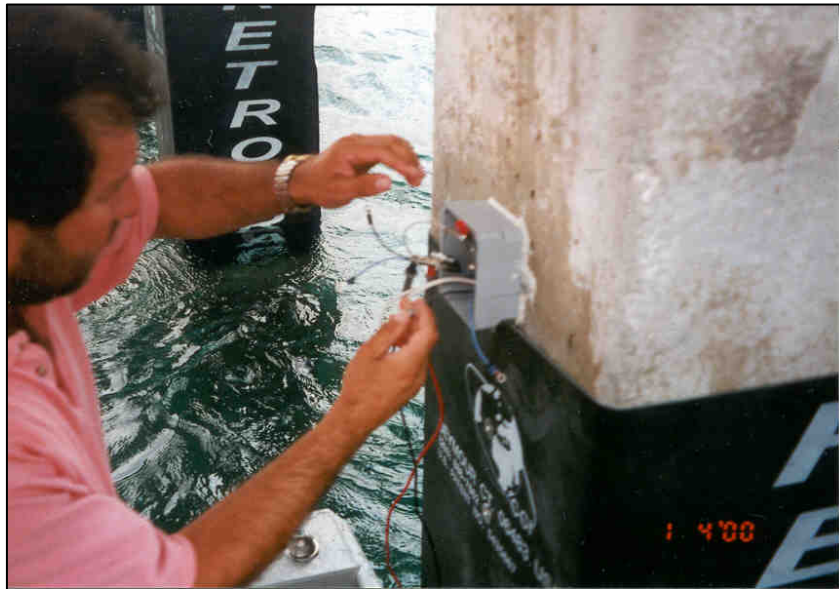
Anode connection terminates within junction box along with output potential monitoring facility.

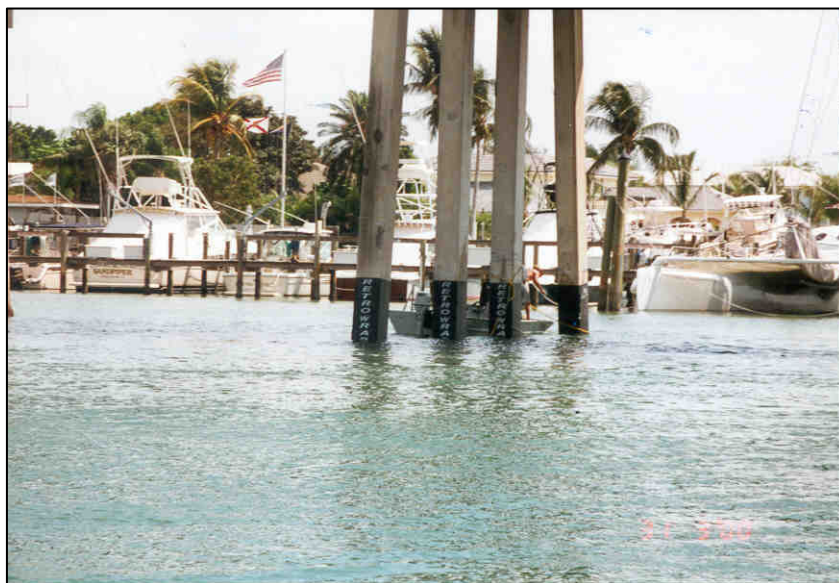
Completed Retrofit installation.
Fast, light weight, and esthetically pleasing to the eye.

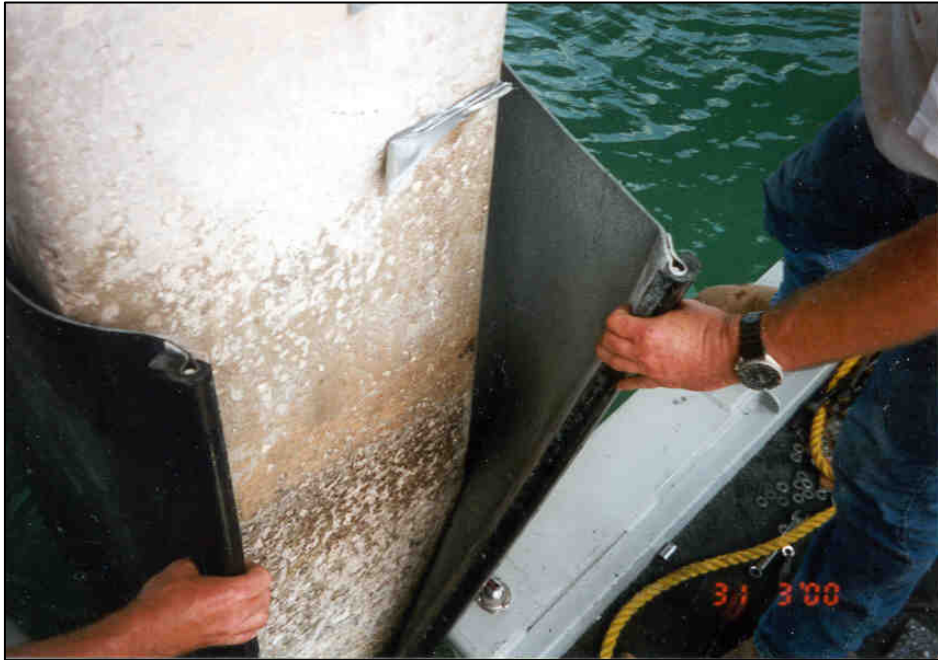
Anode wrap with zinc lined inner face clearly visible being positioned around pile.

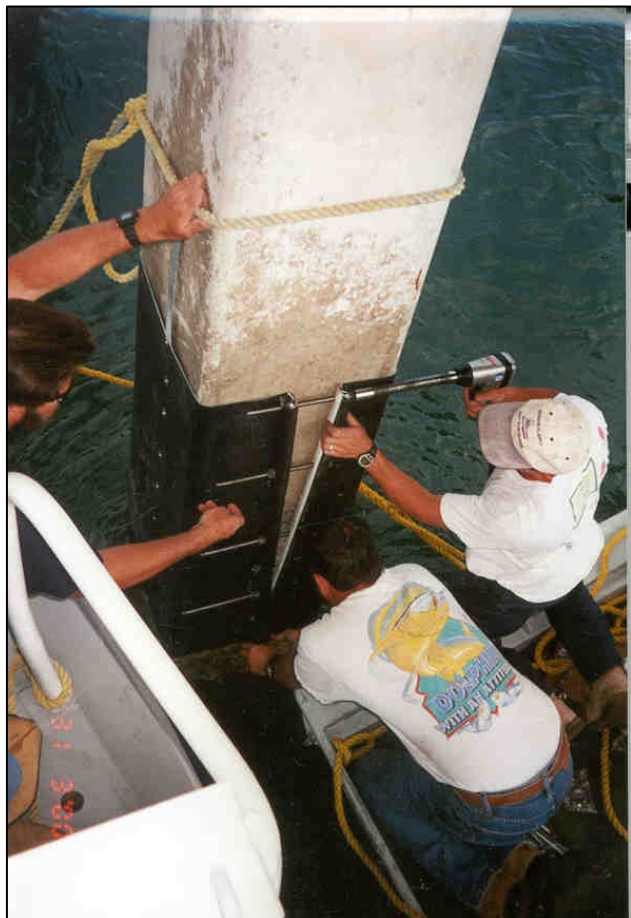
Induced tensioning of wrap underway. Residual elasticity within wrap fabric locks the system in place throughout design life. Zinc anode connection bar visible on left face of pile,
