**MOSCOSO BRIDGE
PUERTO RICO
APRIL 2001**

Moscoso Bridge 1.6 miles dual expressway (405) 42" piles

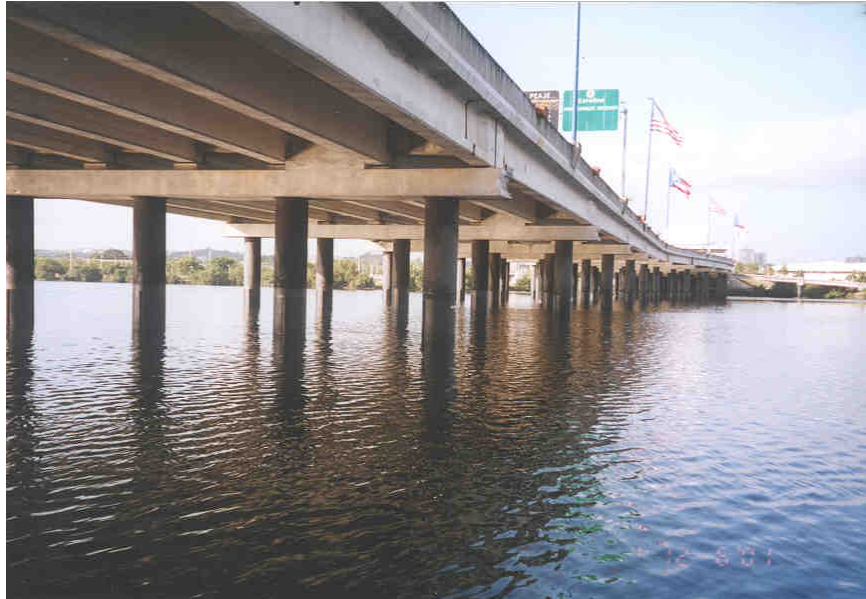
Moscoso Bridge with wraps installed. Toll station end showing density of piles under toll plaza and private access ramp.

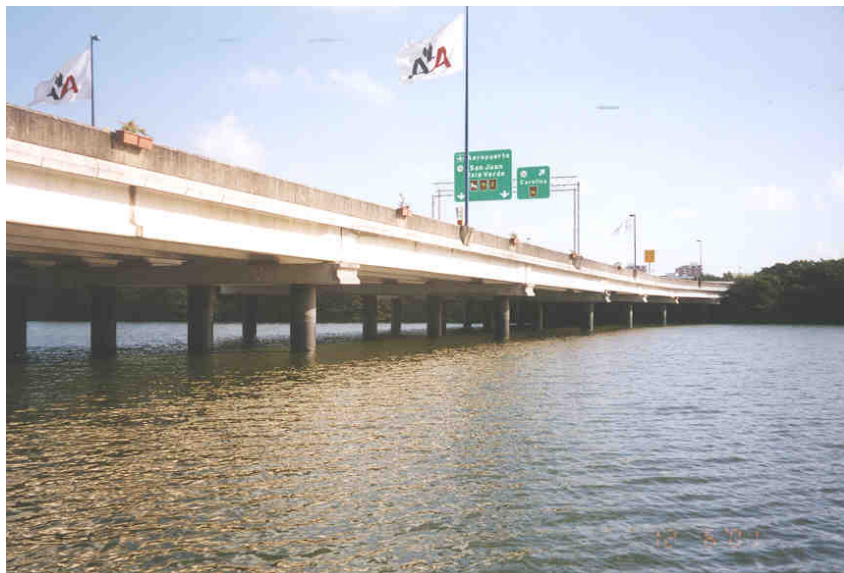
Moscoso Bridge with wraps installed Aeropuerto/San Jose end showing Isle Verde mangroves.

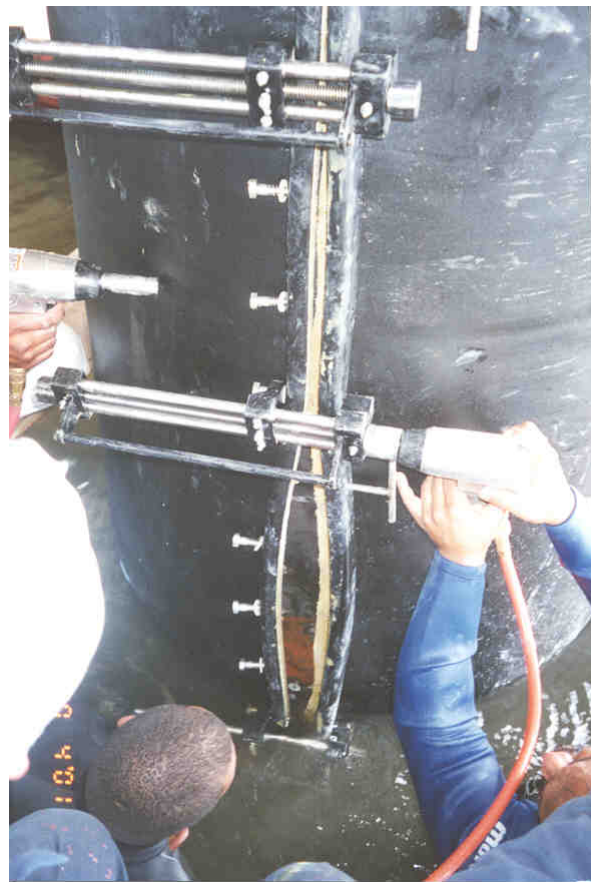
Factory fitted $\frac{1}{2}$ " 316L lag fasteners being driven by impact wrench. Note closure calipers that are used in place of draw bolts.

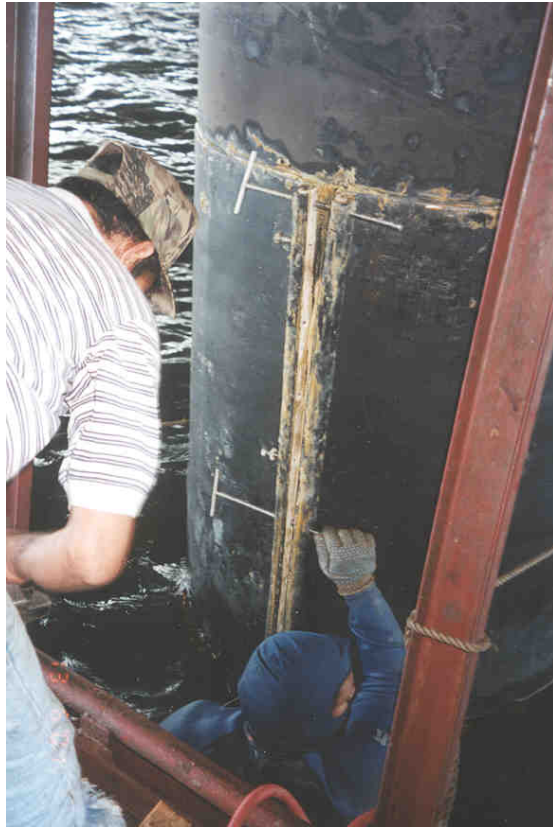
Diver removing line up rod prior to driving lag fasteners

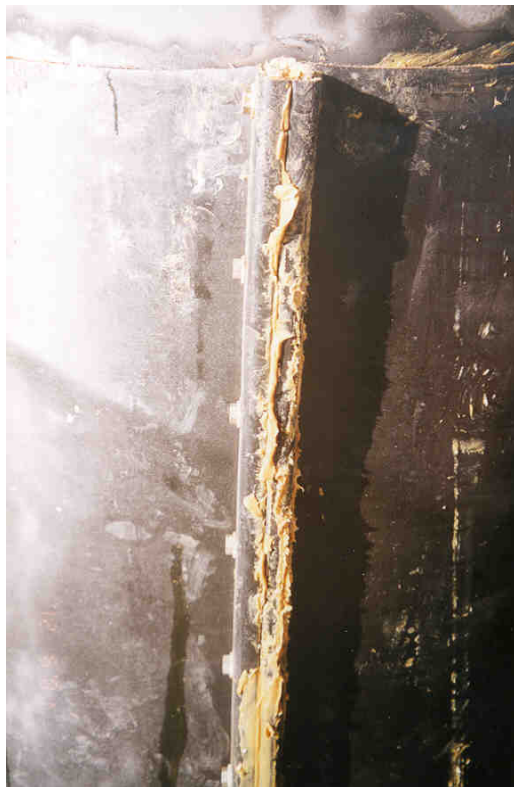
Closure flange showing excess gel exuding after final closure due to residual hoop tension created within wrap fabric.

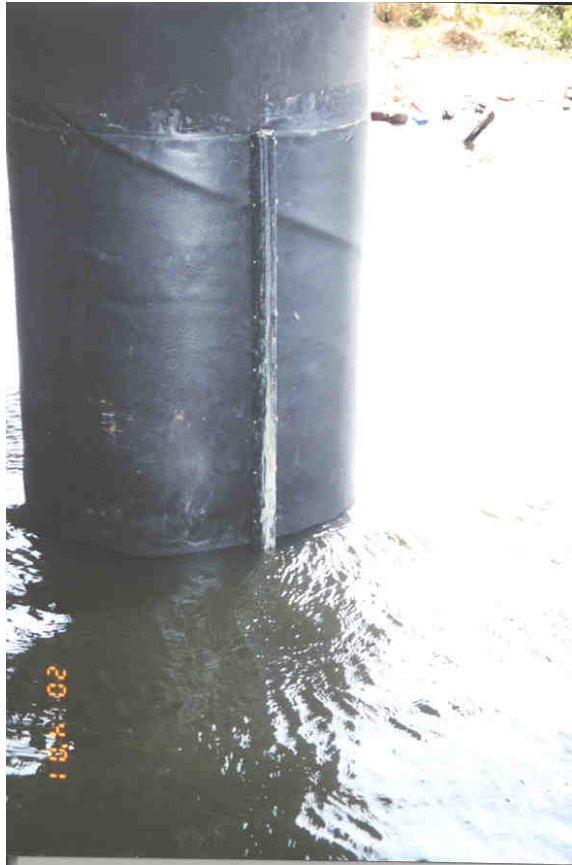
Wrap installation complete. Note spiral weld on pipe pile clearly visible through wrap jacket.

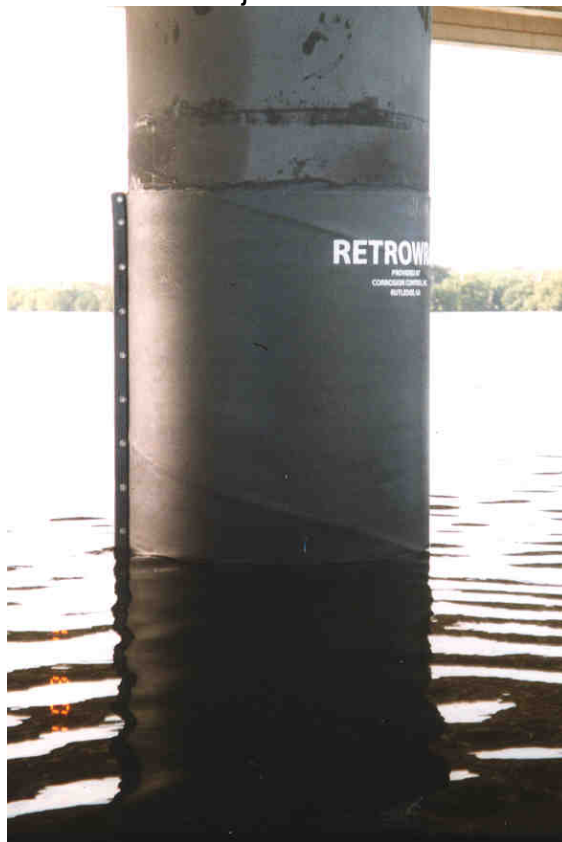
Installed Retrowrap showing closure flange with fasteners fully installed. Also shown is product name and client identification information.

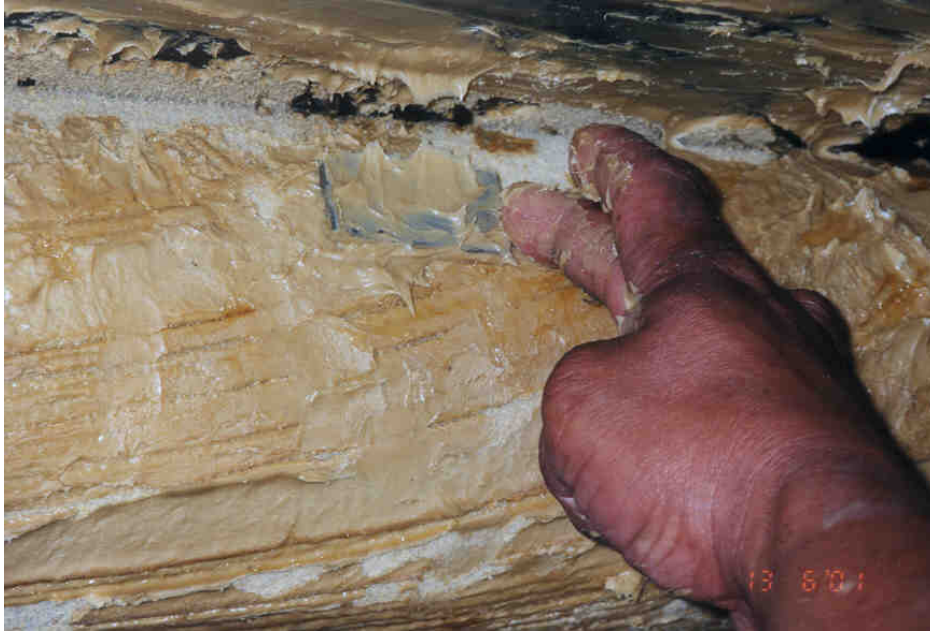
Corrosion rate (weight loss). Sample being fitted under wrap prior to closure. Sample to be removed after 1, 3, and 5 years service to determine corrosion rate. (See formula below).

Test coupons removed after the 6 month exposure period were descaled and then analyzed by visual examination and corrosion weight loss measurements. The difference in coupon weight (if any) after the 6 month period was converted to an average corrosion rate using Faraday's Law and the follow generalized formula (1):

$$\text{Corrosion Rate (mils per year)} = \frac{C \times \Delta \text{ Weight}}{\text{Area} \times \Delta \text{ Time}}$$

C = 2,820, a correction factor based on the density of carbon steel (7.86 gms/sq. cm.) and the particular units of weight, time, and area used in the calculation.
