**Corrosion Control International**

LOCATION: LOMOND – CATS PLATFORM, NORTH SEA

PRODUCT: RETROWRAP HD (6.25mm)

OPERATION: RECLADDING RISERS FROM DEAD WEIGHT SUPPORT  
FLANGE UPWARDS TO RISER CLAMP APPROXIMATELY 6m EACH RISER

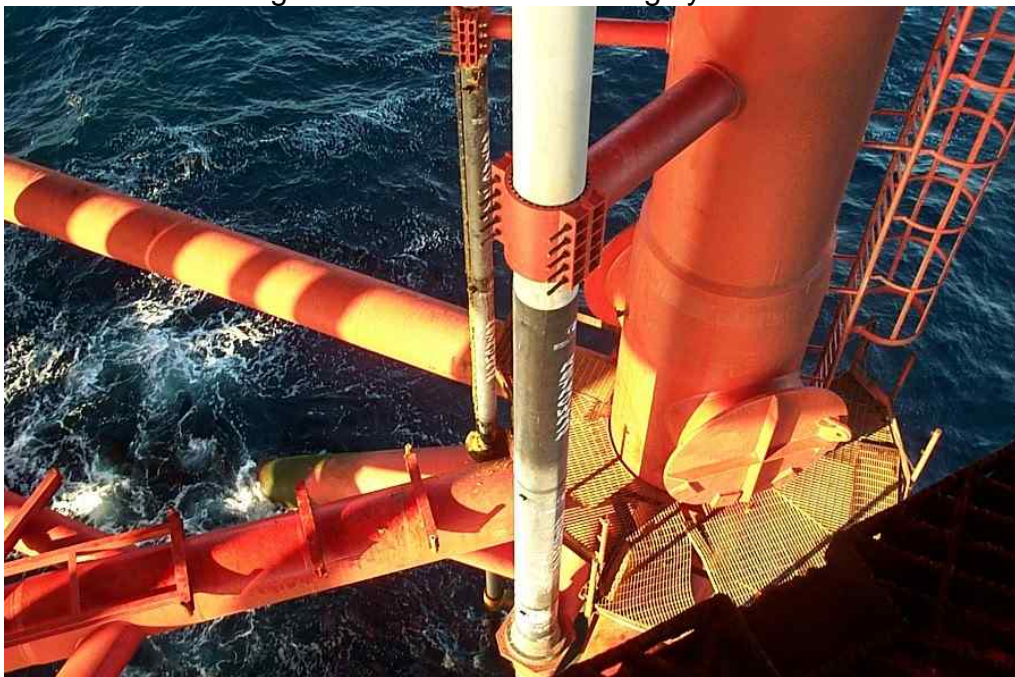
(4)

Dual diameter 244/219 transition unit has been lowered onto dead weight support flange. Note: Draw bolts pre fitted into closure flange.
